Pentium® Pro Processor Specification Update

Release Date: January 1999

Order Number: 242689-035

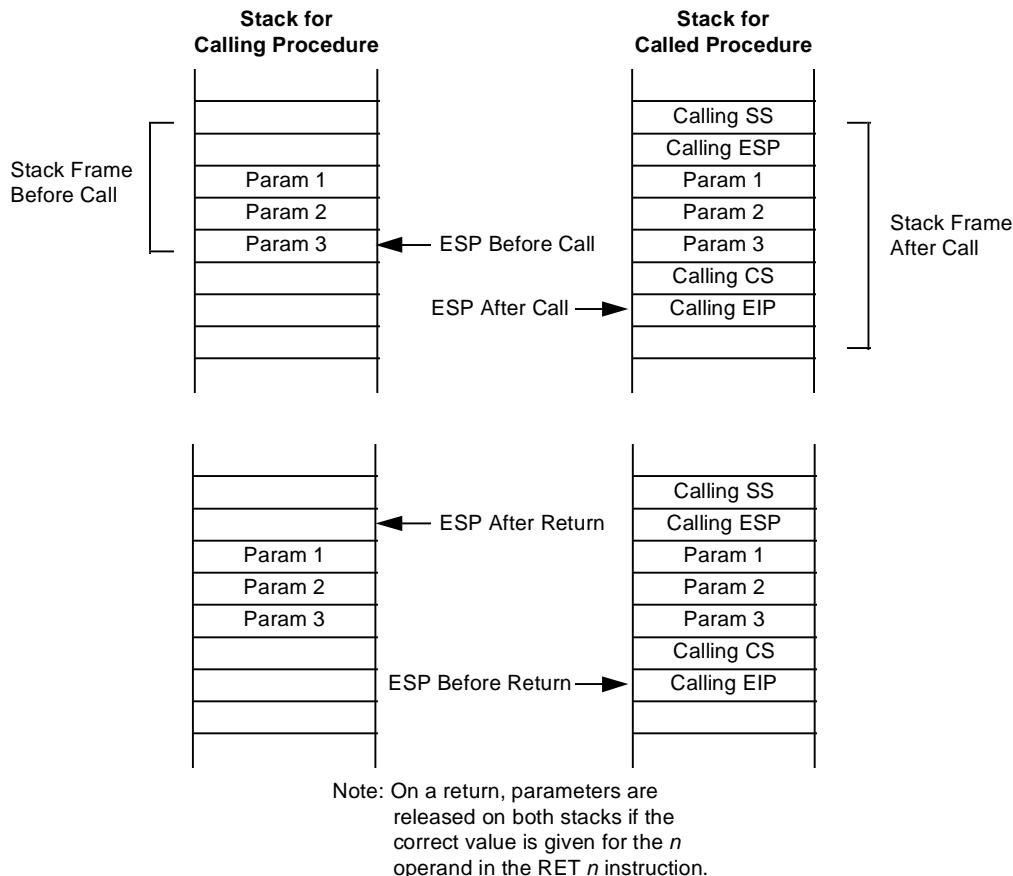
Figure 4-3. Stack Switch on a Call to a Different Privilege Level

When making a call to a more privileged protection level, the processor does the following (see Figure 4-3):

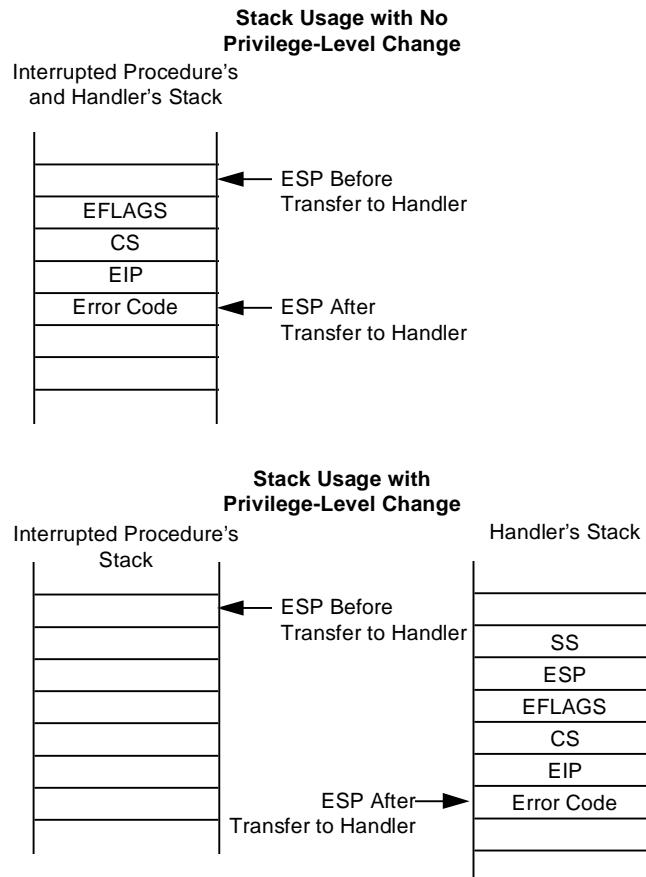
Figure 4-4. Stack Usage on Transfers to Interrupt and Exception Handling Routines
