Intel[®] Pentium[®] II Processor Specification Update

Release Date: July 2002

Order Number: 243337-049

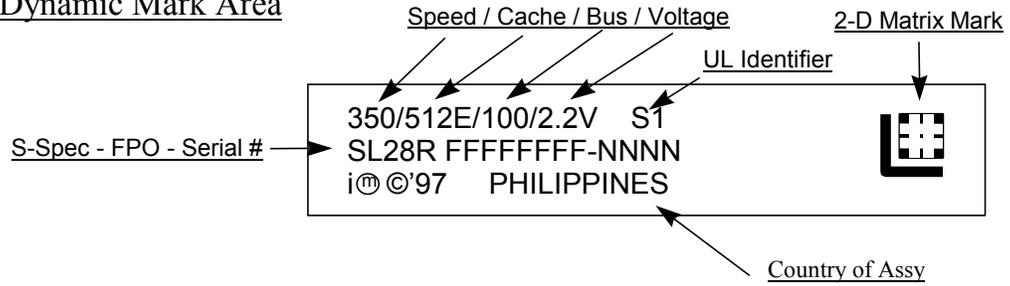
Pentium® II Processor and Boxed Pentium® II Processor 3 Line Markings

Dynamic Mark Area

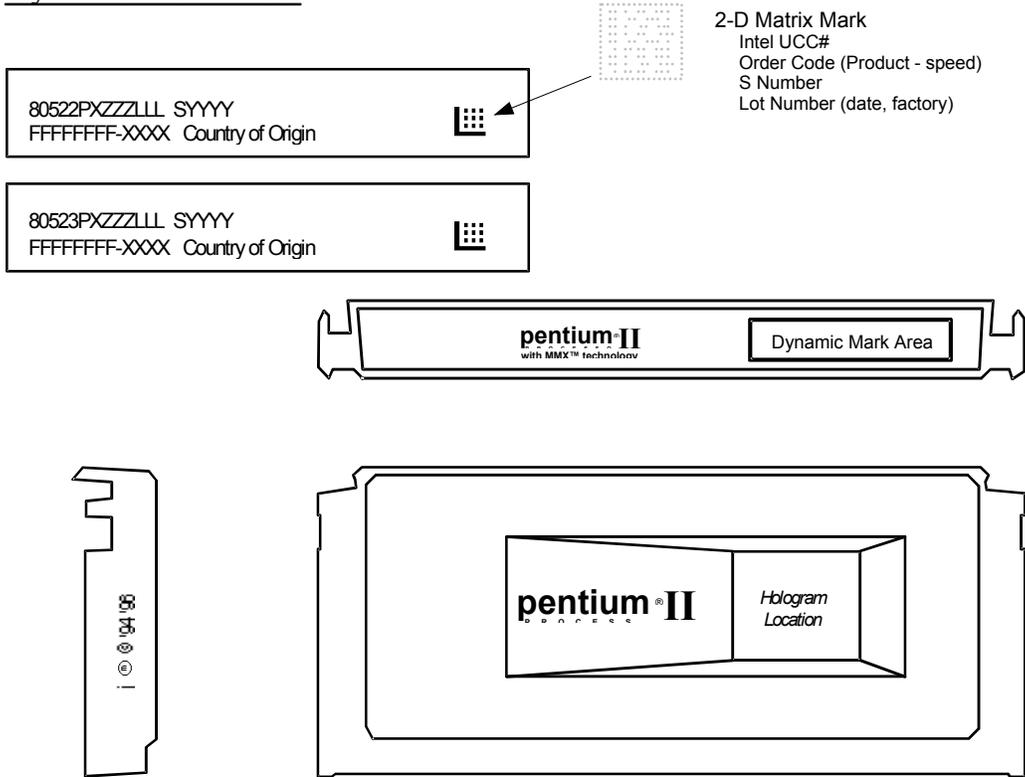
Pentium® II Processor Markings

Dynamic Mark Area

NOTES:

- ZZZ = Speed (MHz).
- SYYYY = S-spec Number.
- LLL = Level 2 Cache Size (in Kilobytes).
- FFFFFFFF = FPO # (Test Lot Traceability #).
- XXXX = Serialization Code.

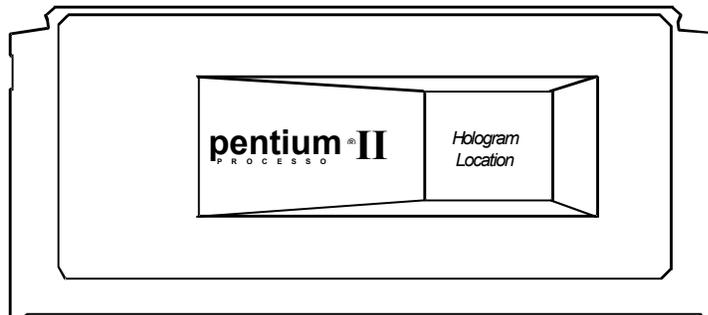
dA-Step Production Units

2-D Matrix Mark
 Intel UCC#
 Order Code (Product - speed)
 S Number
 Lot Number (date, factory)

NOTES:

- ZZZ = Speed (MHz).
- LLL = Level 2 Cache Size (in Kilobytes).
- E = ECC Support in Level 2 Cache
- SYYYY = S-spec Number.
- FFFFFFFF = FPO # (Test Lot Traceability #).
- XXXX = Serialization Code.

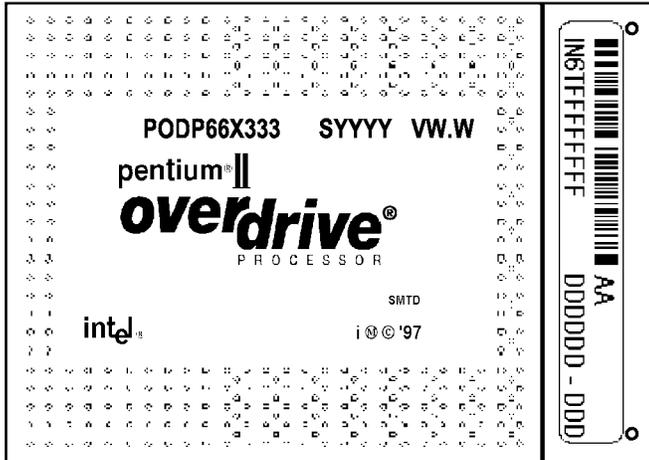
Pentium® II OverDrive® Processor Line Markings
Bottom View of Pentium® II OverDrive® Processor

NOTES:

Label Markings

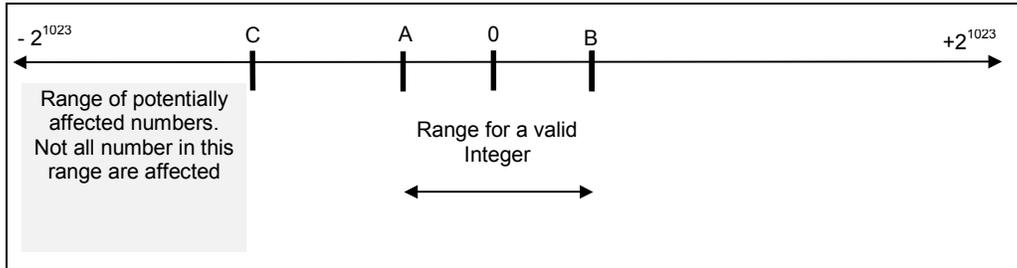
Implication: Erroneous operation results when the operand is so large that it will not fit into the target data size. The operands affected by this erratum are significantly outside (by a factor of 3X) the range that can be, correctly, converted to an integer value. The figure below and corresponding table identifies the normal range of integer numbers (between A and B) and the starting point of the operands affected by this erratum. Discrete failing operands will be present in the range between point C and the maximum negative number that can be represented by the processor (-2^{1023} in double precision format). Note 2 below gives a qualitative description of the nature of the discrete failing values. Software that does not rely on the Invalid Operation exception flag being set and signaled by either an exception OR by software polling is not impacted by this erratum.

16-bit Operation	A	B	C
	-32,768.0	+32,767.0	< -98304.0
32-bit Operation	A	B	C
	-2,147,483,648.0	+2,147,483,647.0	< -6,442,450,944.0
