# Intel<sup>®</sup> Celeron<sup>®</sup> Processor in the 478-Pin Package

Specification Update

Document Number: 290749-030

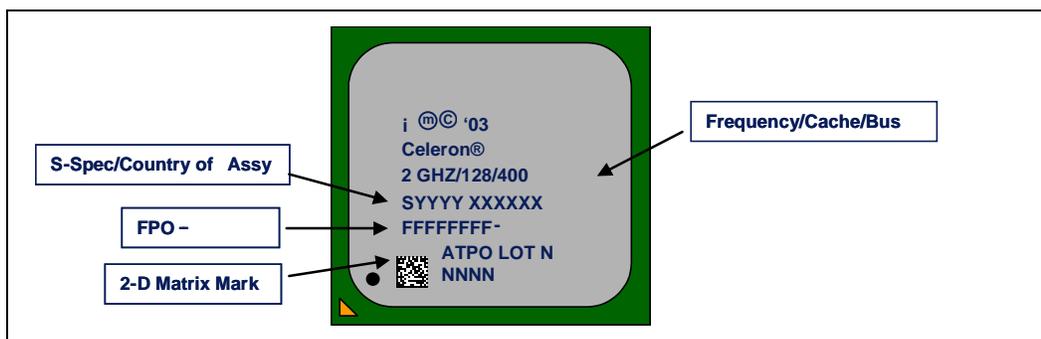
**Figure 1. Example Markings for the Intel® Celeron® Processor on 0.13 Micron Process and/or in the 478-Pin Package**

This section contains top marking information for the Intel® Celeron® processor in the 478-pin package.
